Inspection Report

123 N Anystreet Any Town ID 99999

Inland Northwest Home Inspection LLC

Date: 8/3/2018	Time: 02:00 PM	Report ID: Sample Report 1
Property: 123 N Anystreet Any Town ID 99999	Customer: Inhi Customer	Real Estate Professional:

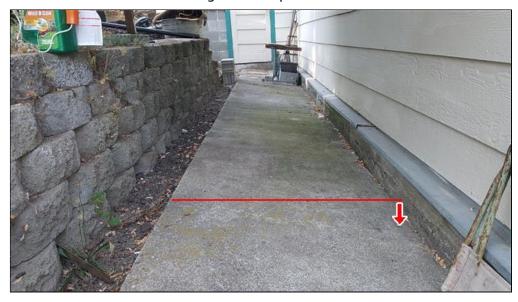
The sidewalk on the back of the house has settled creating a negative grade towards the house. This is allowing water to flow towards house and entering the crawlspace. Recommend further evaluation by licensed contractor to correct grade and proceed as recommended.

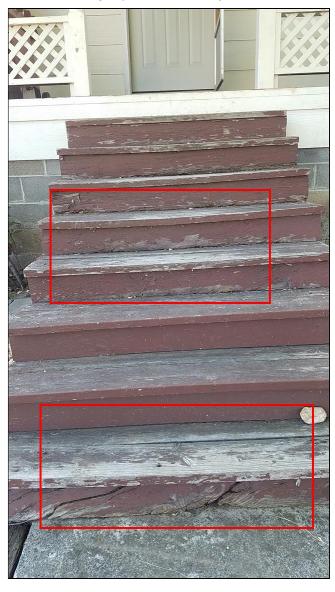
(1) The wood steps to the front door show signs of wood rot and deterioration, as well as loose planking. This is creating a potential safety hazard. Recommend rebuilding steps for safety purposes.

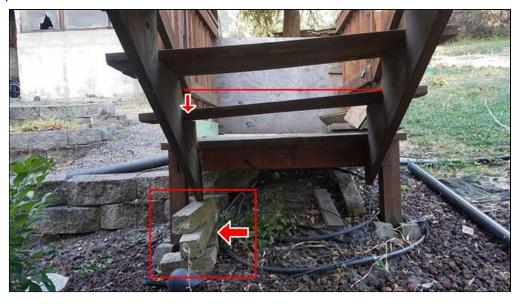
(2) Back steps to upper deck are failing and are a safety hazard. Recommend rebuilding steps properly prior to use.

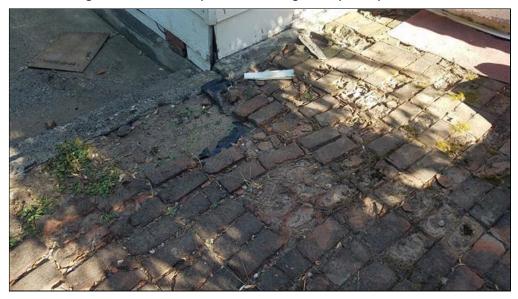
Deteriorating brick and sand patios creating multiple trip hazards. Recommend repair as needed.

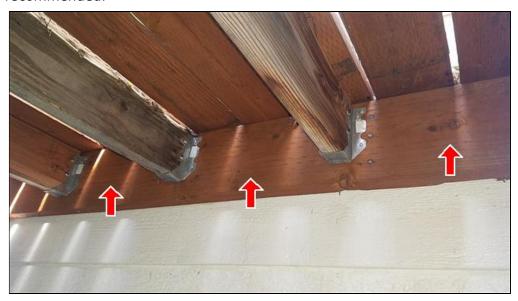
Both upper and lower decks are not properly attached to the house. Deck ledgers should be attached with 1/2 lag bolts on 2 ft centers. Further evaluation for needed repairs by a licensed contractor is recommended.

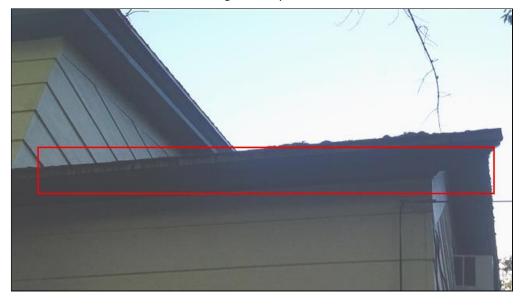
Recommend installing gutters with proper downspouts around the entire house in order to prevent unwanted moisture from entering crawlspace.

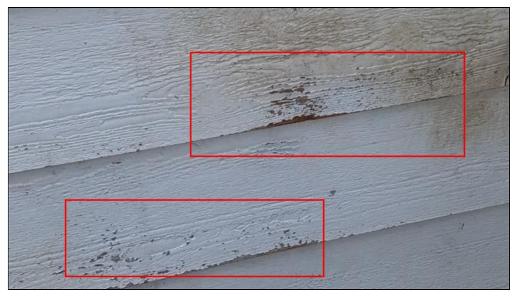
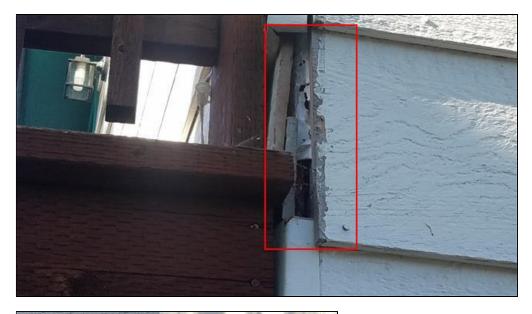
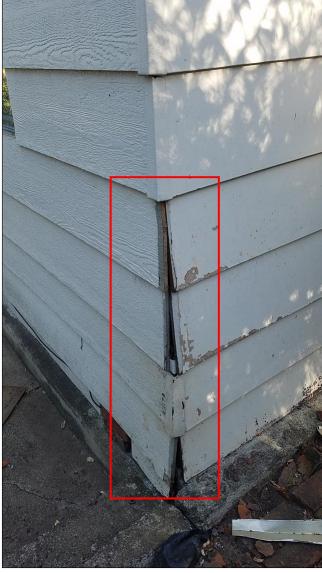
The siding is an overall satisfactory condition with typical maintenance and minor repairs required. Recommend repair as needed, prep and paint/ stain in order to prevent deterioration of the siding. This type of siding is very susceptible to moisture penetration if not properly maintained.

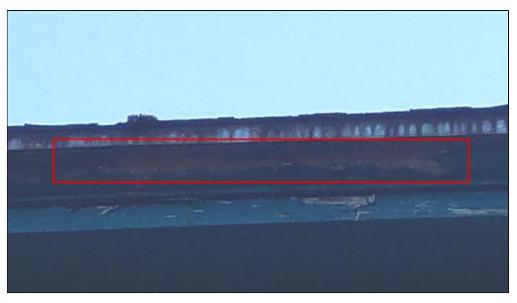
Multiple areas of damaged soffit and fascia. Recommend repair as needed, prep and paint..

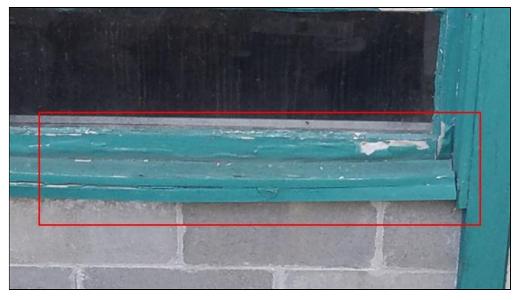
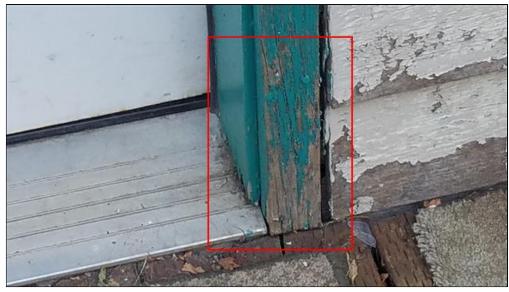
Areas of door, window and / or corner trim that shows signs of wood rot and deterioration due to lack of maintenance. Recommend repairing trim as needed, prep and paint to prevent further deterioration.

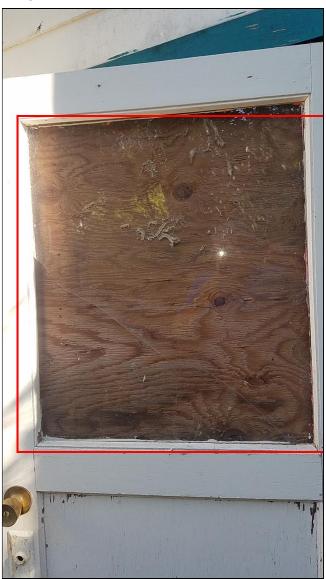
The glass is broken out of the back door. Recommend repair for safety purposes.

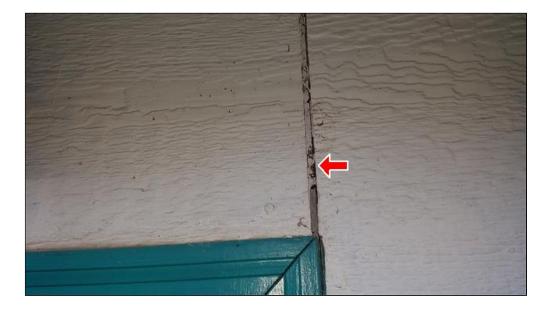
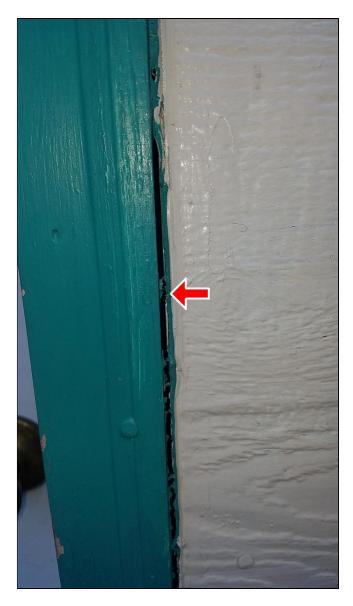
All joints, seams, edges and penetrations should be caulked to prevent moisture penetration resulting in damage and deterioration

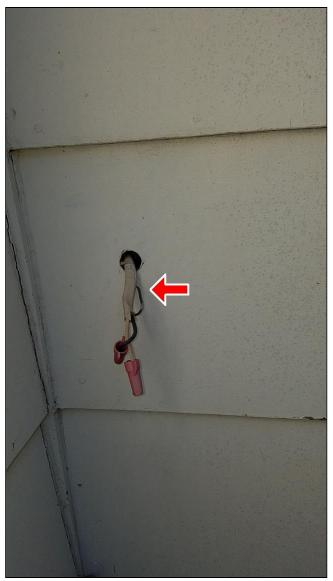
(2) All electrical wiring should be installed in a junction box of proper cover for safety purposes.

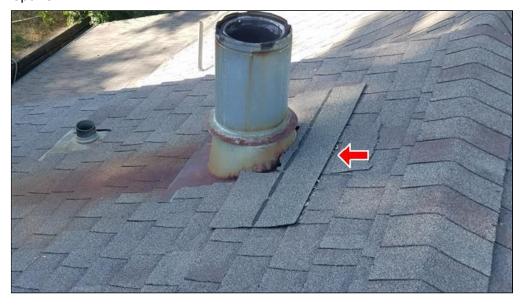
(1) Improperly lapped shingles on roof. Recommend further evaluation by license roofer for all needed repairs.

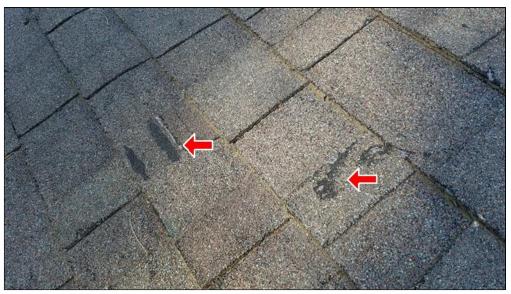
(3) Broken and missing shingles, excessive granule loss and cracking are all indications that the roof is nearing the end of its typical lifespan. Repairs may be needed within the next 5 years.

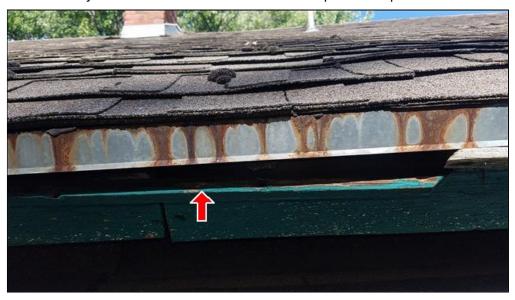
The drip edge is separating from the fascia in multiple sections of the roof. The drip edge prevents water from wicking up the sheathing creating wood rot and possible mold related issues. Recommend further evaluation by a licensed roofer for all needed repairs and proceed as recommended

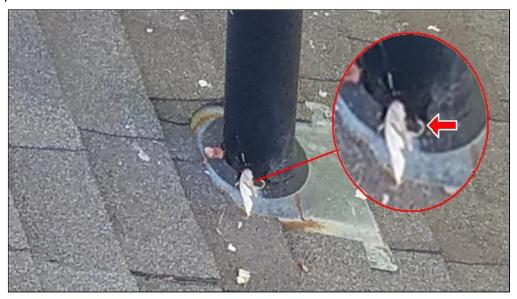
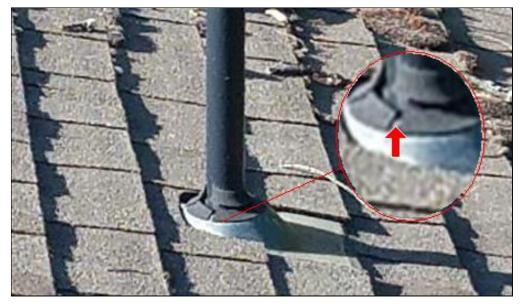
Two plumbing vent flashing Have failed and require replacing. Recommend repair by a qualified professional

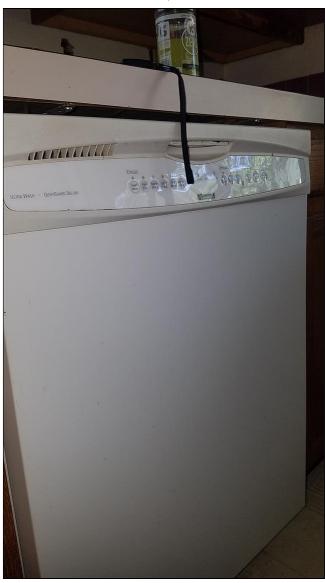
The dishwasher did not operate at the time of the inspection. No determination is made.

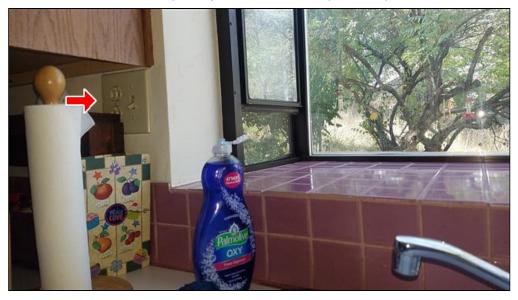
All Outlets within 6 feet of the kitchen sink should be GFI protected for safety purposes. Recommend further evaluation and repair by a licensed and qualified professional.

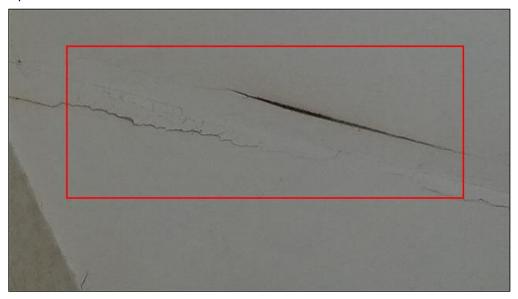
Visible moisture damage on the ceiling due to lack of ventilation. Recommend further evaluation and repair.

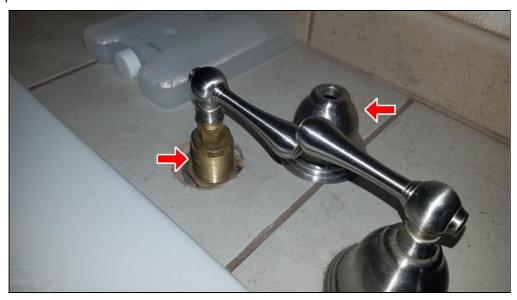
Tub control escutcheon does not attach to valve stem properly. Recommend repair by a licensed plumber.

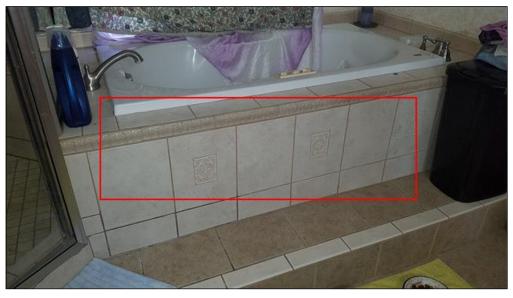
There is no visible access door to the whirlpool tub equipment. Recommend installing access door for servicing purposes.

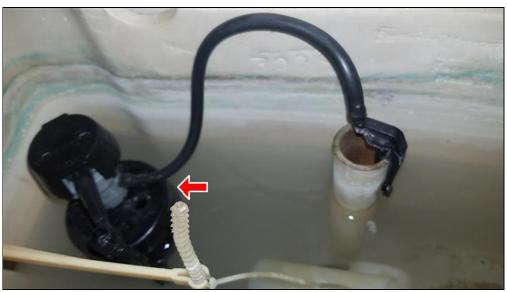
The toilet valve in the 3/4 bath bleeds off and causes the toilet to refill on an approximate 10 minute cycle. Recommend replacing valve.

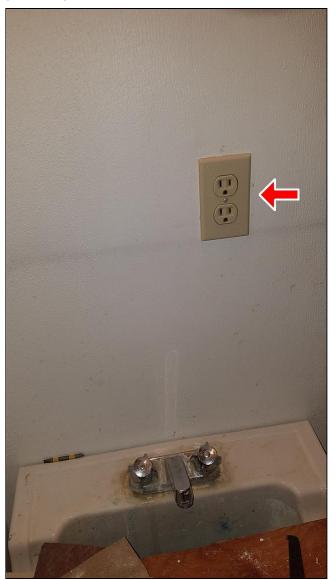
GFI protected outlets are recommended in all bathrooms for safety purposes. Recommend repair by a qualified professional.

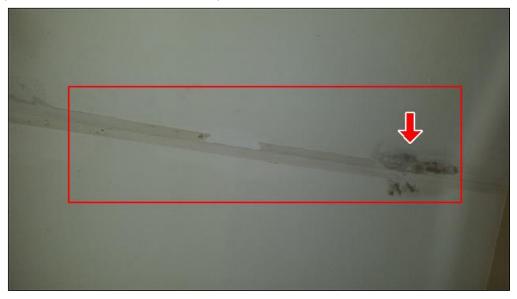
Damaged ceilings throughout the house with possible organic growth indicating a moisture related problem.(ie: lack of ventilation, possible leak) Recommend further evaluation for needed repairs.

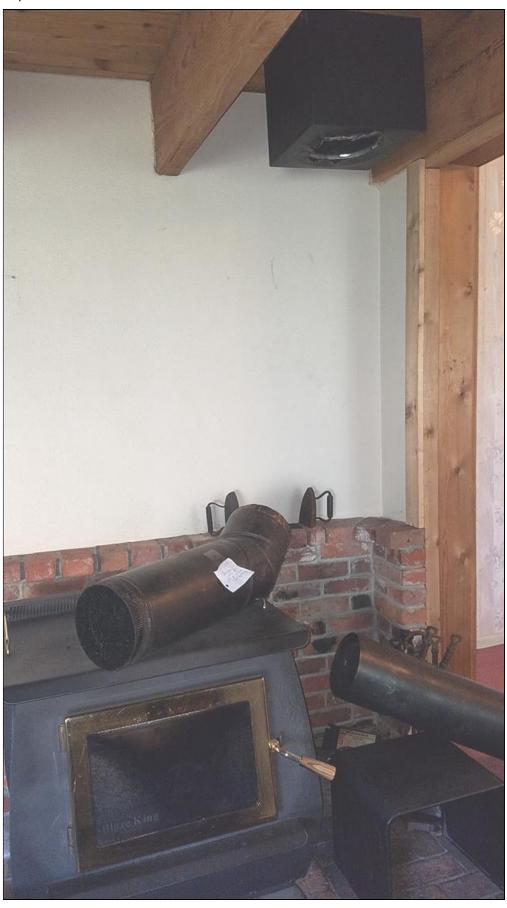
(1) The wood burning stove in the living room was not completely installed up at the time of the inspection. No determination is made.

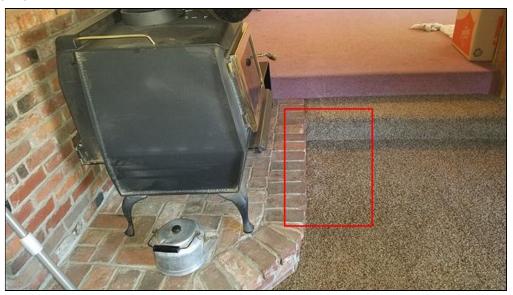
(2) A non flammable surface should extend a minimum of 18 in from the front of the stove for safety purposes.

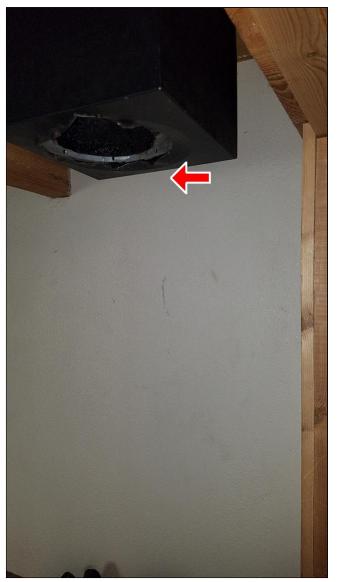
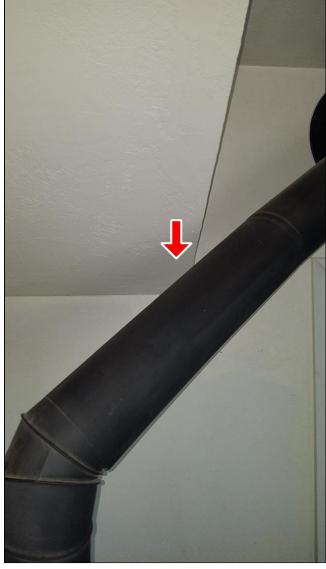
(3) There is a minimum clearance requirement between single wall stove pipes and flammable surfaces. Recommend consulting with a license HVAC contractor to insure proper clearance is met.

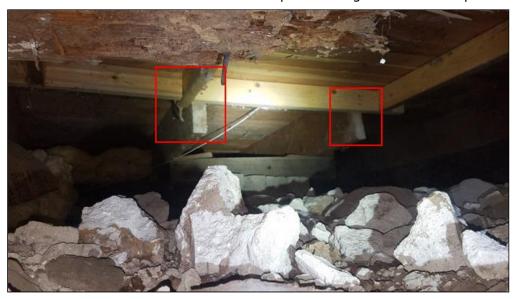
Multiple floor joists have been improperly repaired and modified. Recommend further evaluation by a licensed contractor for needed needed repairs throughout the crawlspace and proceed as recommended.

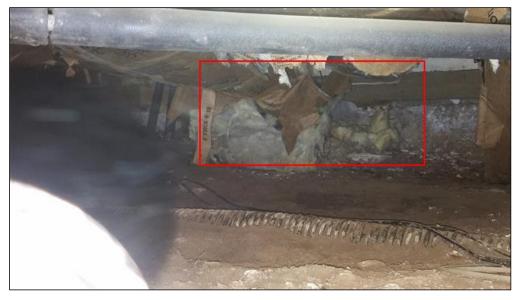
Insulation is falling down in multiple areas in his being used as nesting material. Recommend further evaluation of entire crawlspace for all needed repairs.

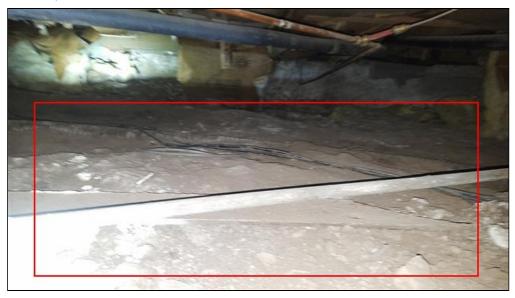
The vapor barrier is missing throughout the crawlspace and there is visible moisture in areas of the crawlspace. Recommend installing vapor barrier throughout the entire crawlspace to prevent moisture related problems.

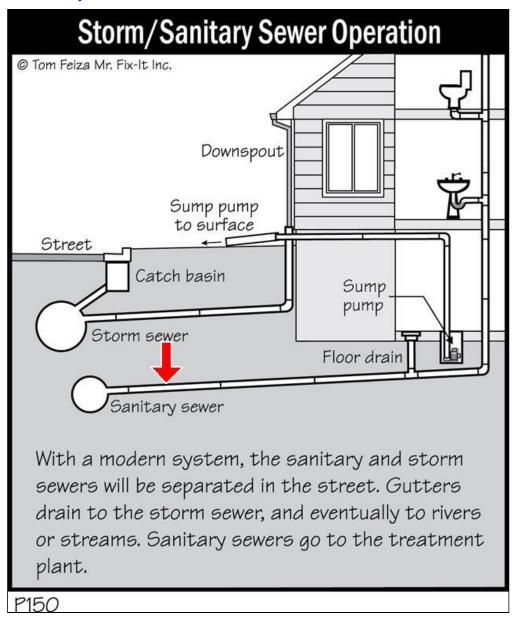
123 N Anystreet Page 54 of 105 Due to the age of the home recommendation is to have main sewer line scoped to determine material and stability of the line.

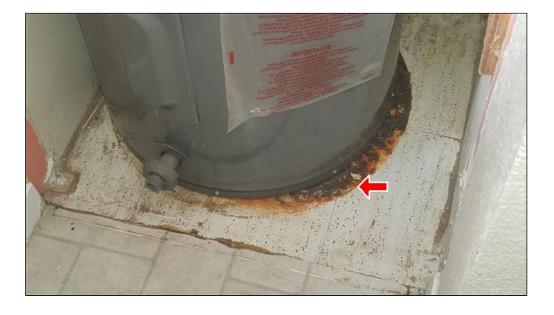
(2) Drip pans have been required below water heaters since 2012. Recommend installing drip pan. Water heater in bathroom.

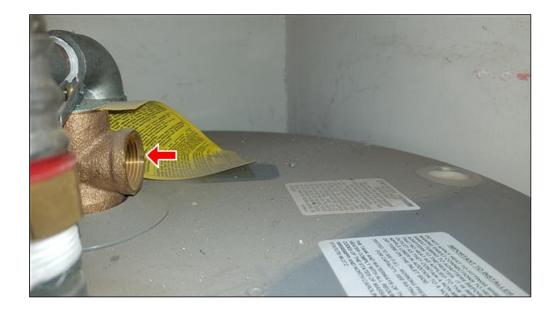
Both water heaters.

The TPR valve extension is missing or too short. Code requires that the extension extends to no more than 6 inches above the floor. The desired location is for the line to extend to a floor drain if accessible or to the exterior of the home.

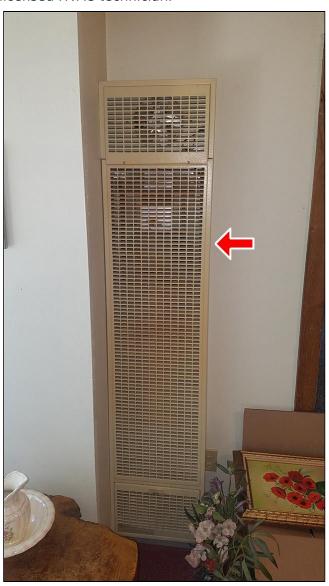
The gas wall heater did not operate at the time of the inspection. Recommend further evaluation by licensed HVAC technician.
