Inspection Report

123 N Anystreet Any Town ID 99999

Inland Northwest Home Inspection LLC

Date: 8/3/2018	Time: 02:00 PM	Report ID: Sample Report 1
Property: 123 N Anystreet Any Town ID 99999	Customer: Inhi Customer	Real Estate Professional:

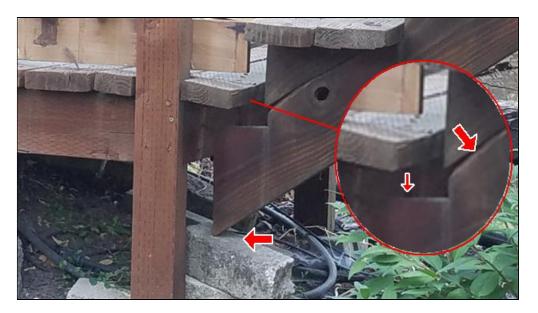
(2) Back steps to upper deck are failing and are a safety hazard. Recommend rebuilding steps properly prior to use.

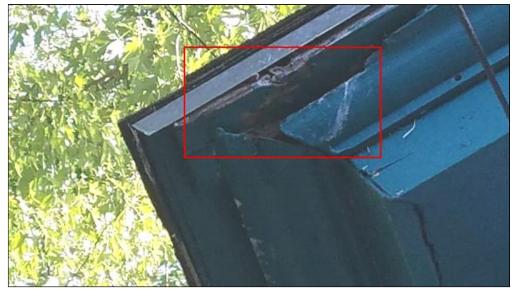
Multiple areas of damaged soffit and fascia. Recommend repair as needed, prep and paint..

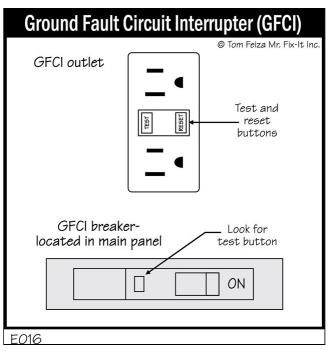
GFI Breaker/ outlet

(1) All exterior outlets should be GFI protected for safety purposes. Recommend installing GFI protection for exterior outlets. (Either GFI outlets or breaker)

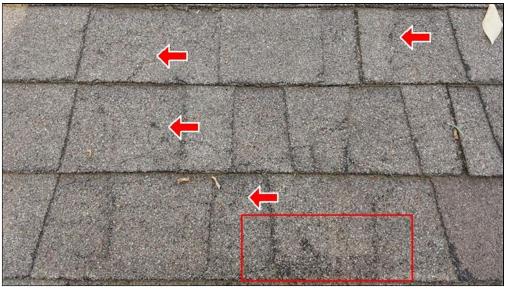
(3) Broken and missing shingles, excessive granule loss and cracking are all indications that the roof is nearing the end of its typical lifespan. Repairs may be needed within the next 5 years.

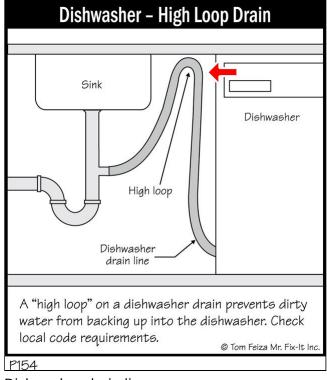
Dishwasher drain line should either be looped at the high point in cabinet or have an air gap installed to prevent backflow from the sink to the dishwasher.

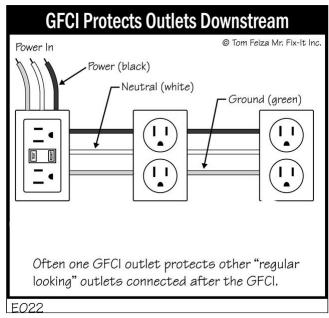
Daisy chain GFI

All Outlets within 6 feet of the kitchen sink should be GFI protected for safety purposes. Recommend further evaluation and repair by a licensed and qualified professional.

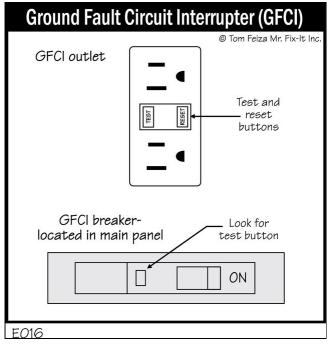
GFI protection

GFI protected outlets are recommended in all bathrooms for safety purposes. Recommend repair by a qualified professional.

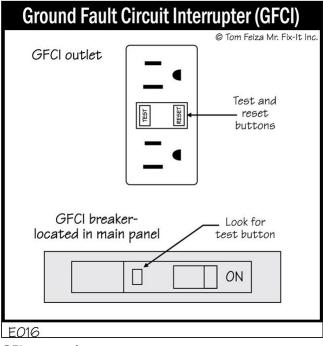
GFI protection

GFI protected outlets are recommended in all bathrooms for safety purposes. Recommend repair by a qualified professional.

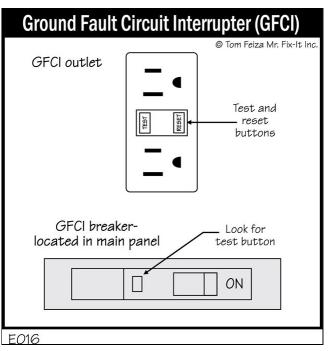
GFI protection

GFI protected outlets are recommended in all bathrooms for safety purposes. Recommend repair by a qualified professional.

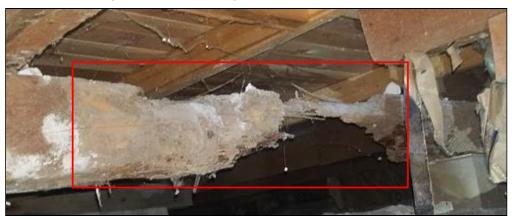
Evidence of a wood destroying organism and failed beam due to the a wood destroying organism. Recommend further evaluation by license pest inspector and further evaluation by a licensed contractor for all needed repairs in the crawlspace.

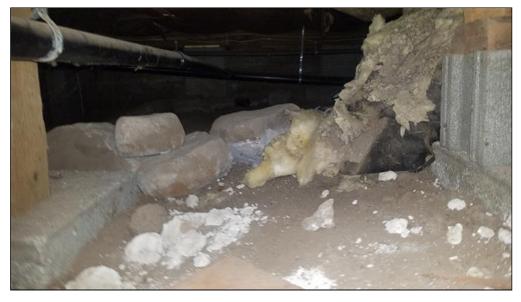
Leftover debris and wood in crawlspace should be cleaned out to prevent possible WDO's

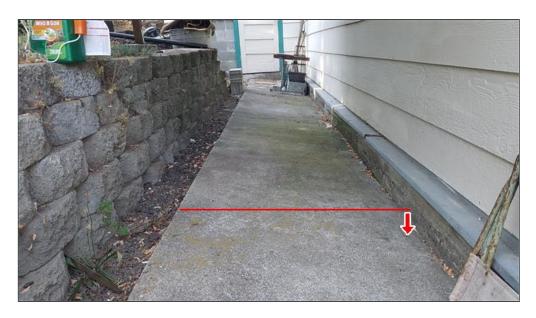
The sidewalk on the back of the house has settled creating a negative grade towards the house. This is allowing water to flow towards house and entering the crawlspace. Recommend further evaluation by licensed contractor to correct grade and proceed as recommended.

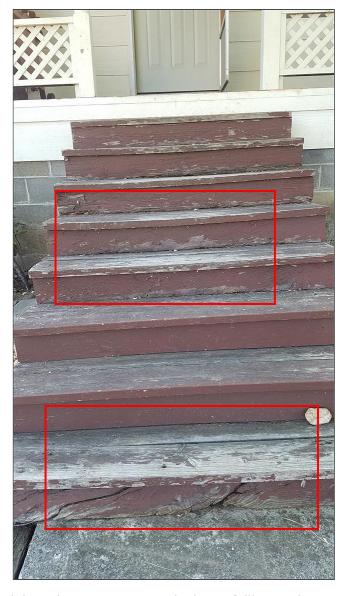
(1) The wood steps to the front door show signs of wood rot and deterioration, as well as loose planking. This is creating a potential safety hazard. Recommend rebuilding steps for safety purposes.

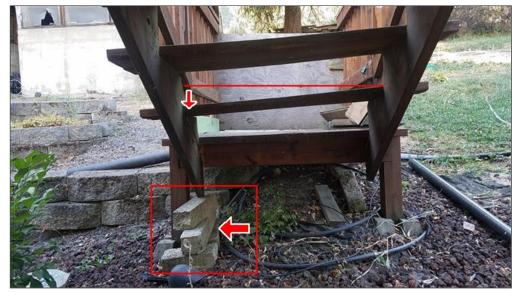
(2) Back steps to upper deck are failing and are a safety hazard. Recommend rebuilding steps properly prior to use.

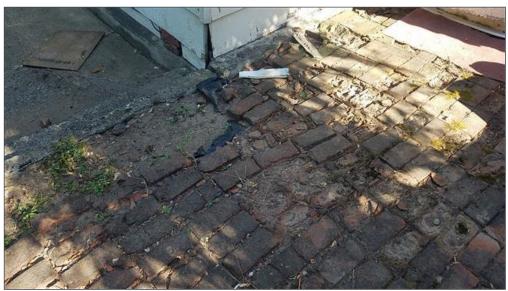
Deteriorating brick and sand patios creating multiple trip hazards. Recommend repair as needed.

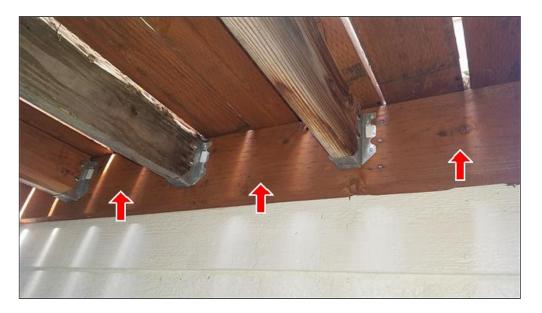
Both upper and lower decks are not properly attached to the house. Deck ledgers should be attached with 1/2 lag bolts on 2 ft centers. Further evaluation for needed repairs by a licensed contractor is recommended.

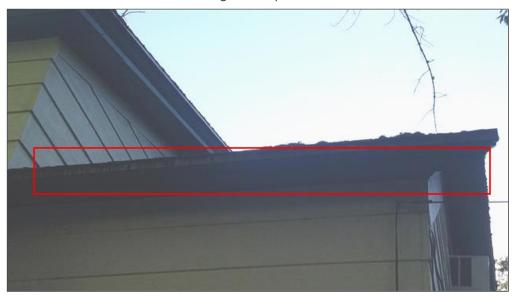
Recommend installing gutters with proper downspouts around the entire house in order to prevent unwanted moisture from entering crawlspace.

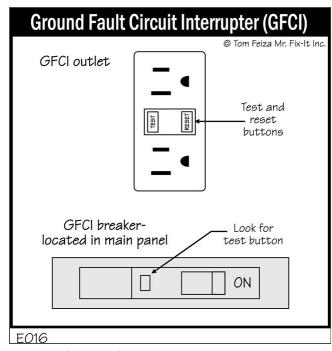
GFI Breaker/ outlet

(1) All exterior outlets should be GFI protected for safety purposes. Recommend installing GFI protection for exterior outlets. (Either GFI outlets or breaker)

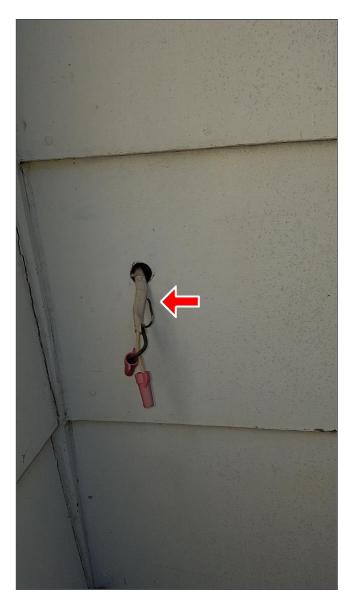
(2) All electrical wiring should be installed in a junction box of proper cover for safety purposes.

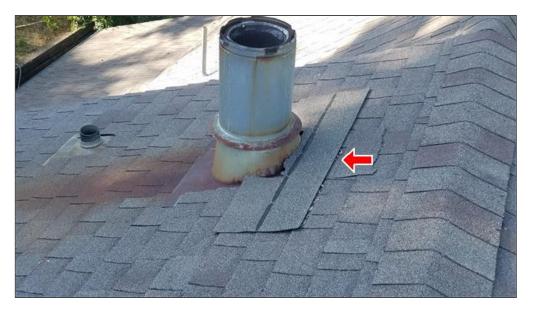
Inspected, Item of Concern, Maintenance / Monitor Recommended, Deffered cost item (1) Improperly lapped shingles on roof. Recommend further evaluation by license roofer for all needed repairs.

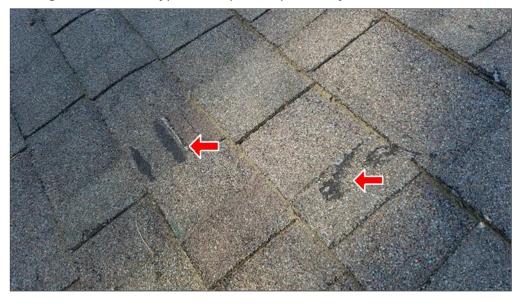
(3) Broken and missing shingles, excessive granule loss and cracking are all indications that the roof is nearing the end of its typical lifespan. Repairs may be needed within the next 5 years.

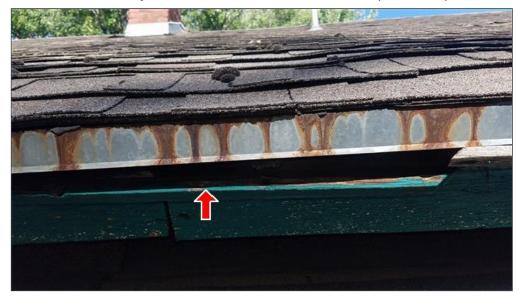
The drip edge is separating from the fascia in multiple sections of the roof. The drip edge prevents water from wicking up the sheathing creating wood rot and possible mold related issues. Recommend further evaluation by a licensed roofer for all needed repairs and proceed as recommended

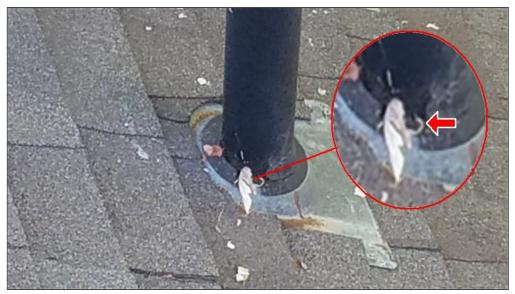
Two plumbing vent flashing Have failed and require replacing. Recommend repair by a qualified professional

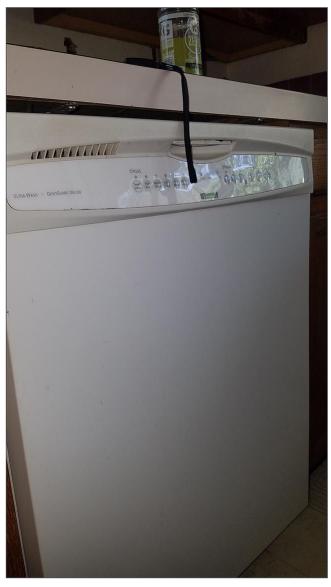
The dishwasher did not operate at the time of the inspection. No determination is made.

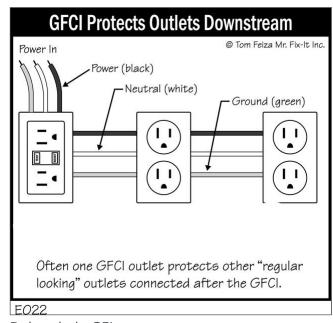
Daisy chain GFI

All Outlets within 6 feet of the kitchen sink should be GFI protected for safety purposes. Recommend further evaluation and repair by a licensed and qualified professional.

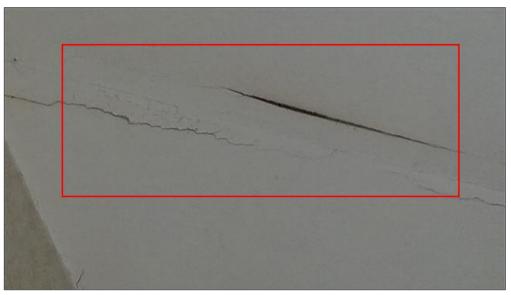
Visible moisture damage on the ceiling due to lack of ventilation. Recommend further evaluation and repair.

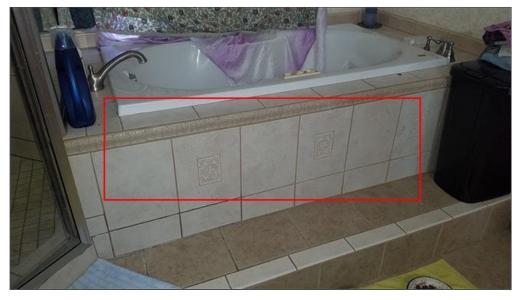
There is no visible access door to the whirlpool tub equipment. Recommend installing access door for servicing purposes.

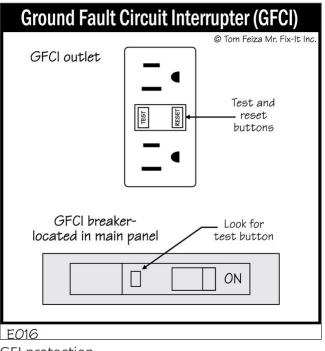
GFI protected outlets are recommended in all bathrooms for safety purposes. Recommend repair by a qualified professional.

GFI protection

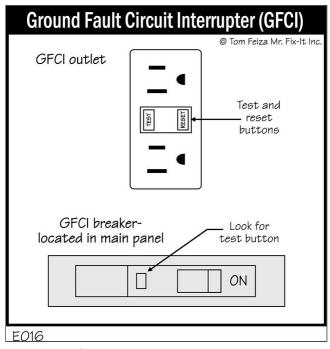
GFI protected outlets are recommended in all bathrooms for safety purposes. Recommend repair by a qualified professional.

GFI protection

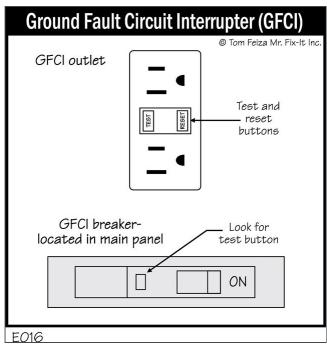
GFI protected outlets are recommended in all bathrooms for safety purposes. Recommend repair by a qualified professional.

GFI protection

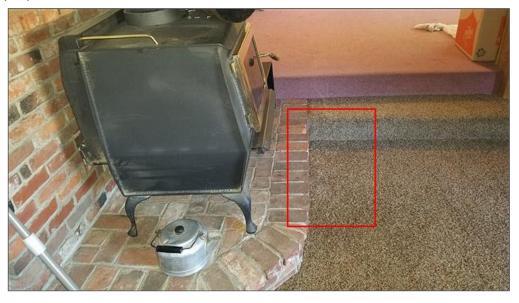
(2) A non flammable surface should extend a minimum of 18 in from the front of the stove for safety purposes.

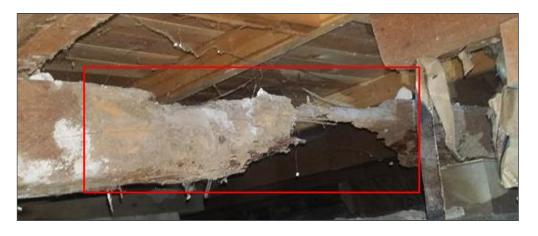
Evidence of a wood destroying organism and failed beam due to the a wood destroying organism. Recommend further evaluation by license pest inspector and further evaluation by a licensed contractor for all needed repairs in the crawlspace.

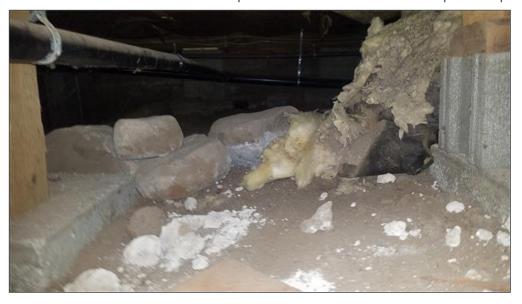
Leftover debris and wood in crawlspace should be cleaned out to prevent possible WDO's

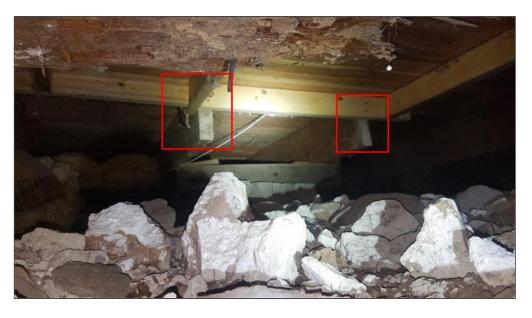
Multiple floor joists have been improperly repaired and modified. Recommend further evaluation by a licensed contractor for needed needed repairs throughout the crawlspace and proceed as recommended.

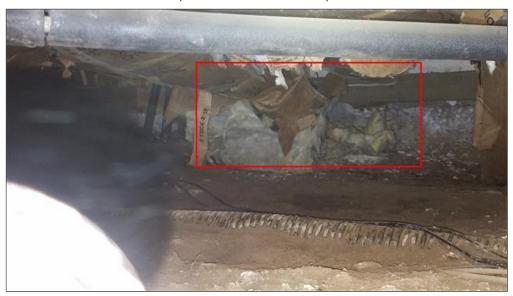
Insulation is falling down in multiple areas in his being used as nesting material. Recommend further evaluation of entire crawlspace for all needed repairs.

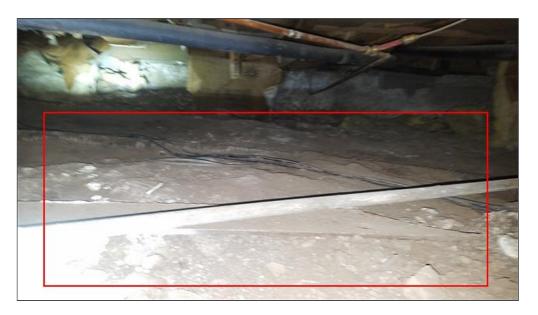
The vapor barrier is missing throughout the crawlspace and there is visible moisture in areas of the crawlspace. Recommend installing vapor barrier throughout the entire crawlspace to prevent moisture related problems.

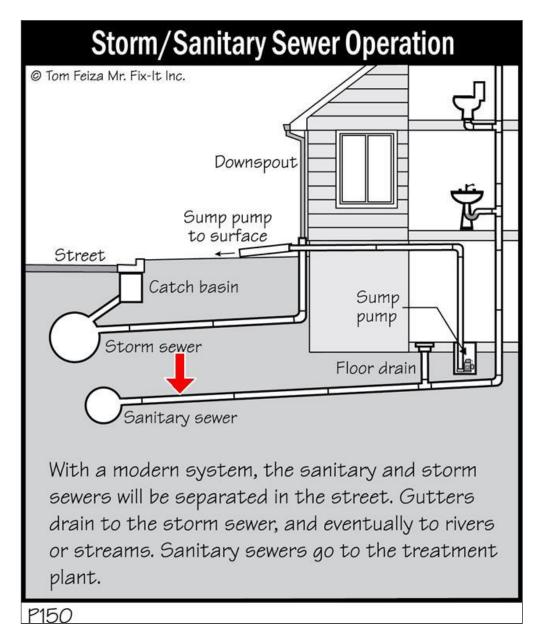
Due to the age of the home recommendation is to have main sewer line scoped to determine material and stability of the line.

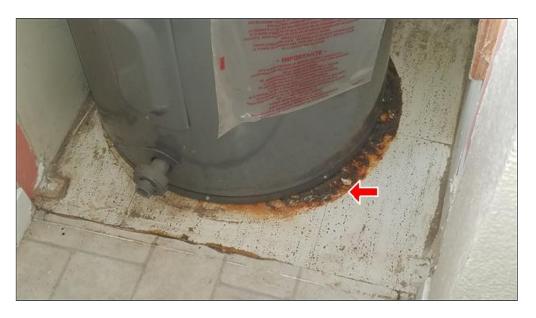
(2) Drip pans have been required below water heaters since 2012. Recommend installing drip pan.

Water heater in bathroom.

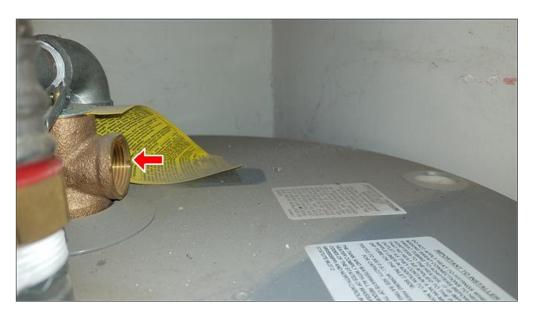
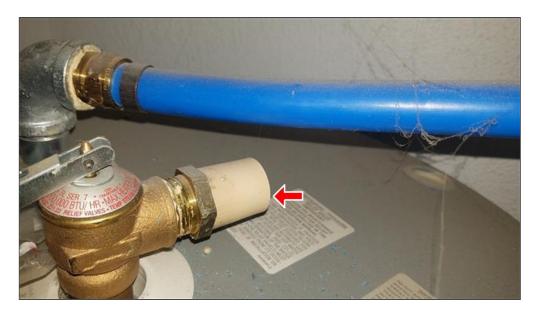
The TPR valve extension is missing or too short. Code requires that the extension extends to no more than 6 inches above the floor. The desired location is for the line to extend to a floor drain if accessible or to the exterior of the home.

Both water heaters.

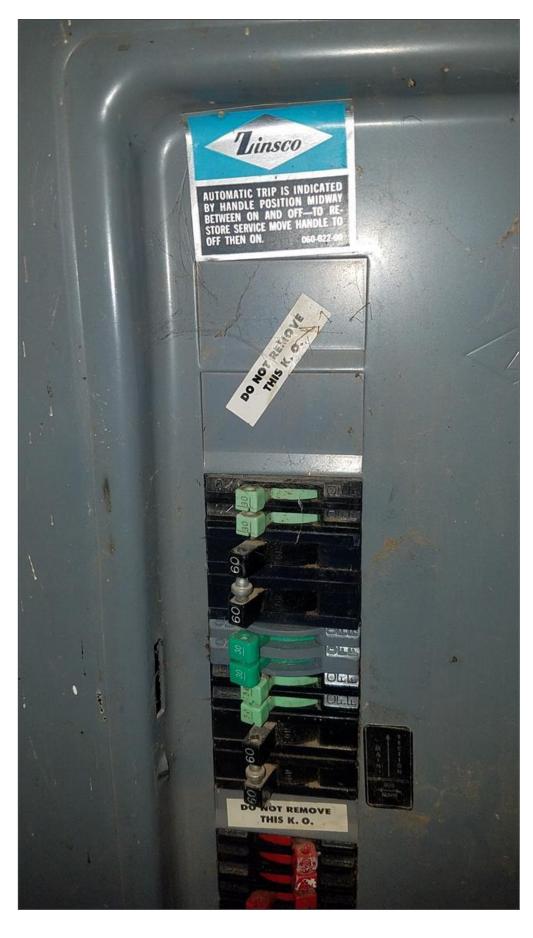
Sylvania/ Zinsco electrical panels are obsolete and a potential safety hazard. Recommend further evaluation by a licensed electrician and proceed as recommended.

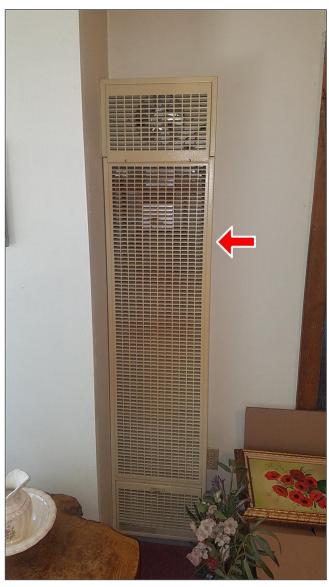
The gas wall heater did not operate at the time of the inspection. Recommend further evaluation by licensed HVAC technician.

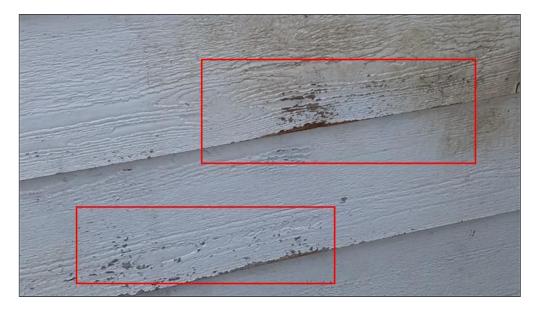
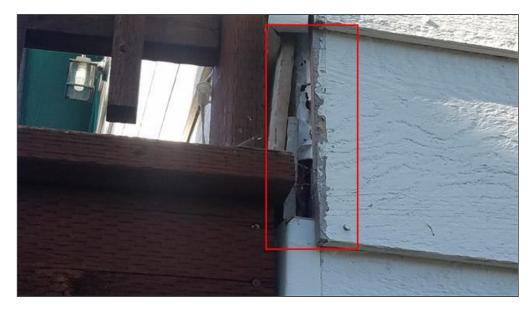
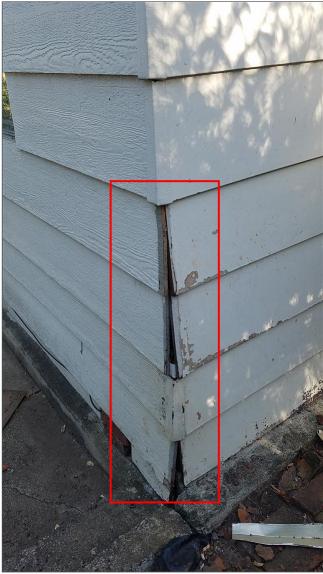
The siding is an overall satisfactory condition with typical maintenance and minor repairs required. Recommend repair as needed, prep and paint/ stain in order to prevent deterioration of the siding. This type of siding is very susceptible to moisture penetration if not properly maintained.

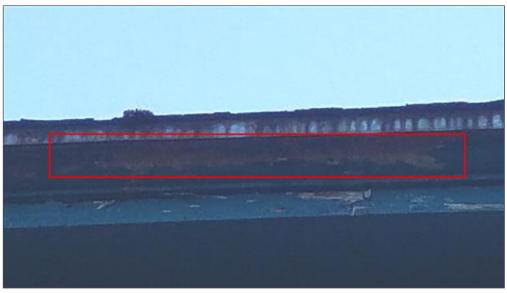
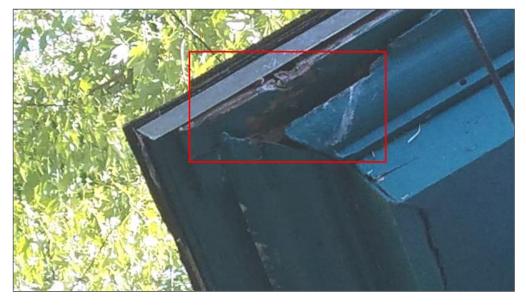
Multiple areas of damaged soffit and fascia. Recommend repair as needed, prep and paint..

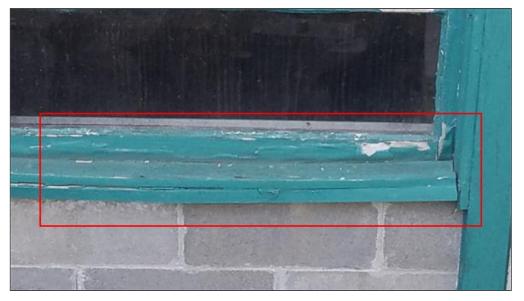
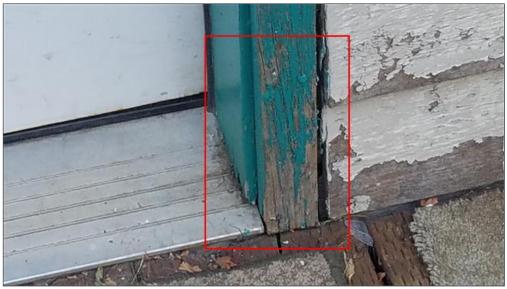
Areas of door, window and / or corner trim that shows signs of wood rot and deterioration due to lack of maintenance. Recommend repairing trim as needed, prep and paint to prevent further deterioration.

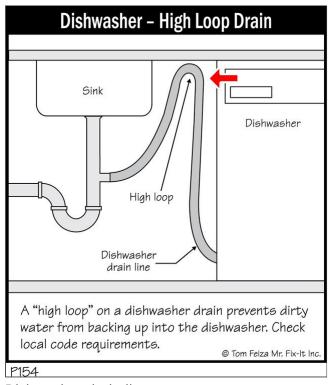
Dishwasher drain line should either be looped at the high point in cabinet or have an air gap installed to prevent backflow from the sink to the dishwasher.

Dishwasher drain line

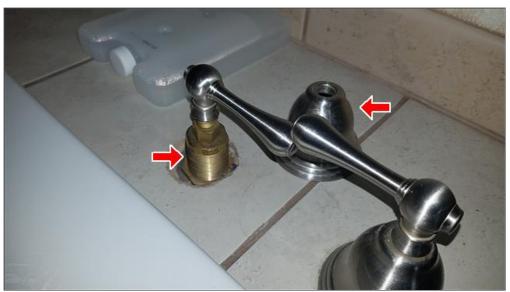
Tub control escutcheon does not attach to valve stem properly. Recommend repair by a licensed plumber.

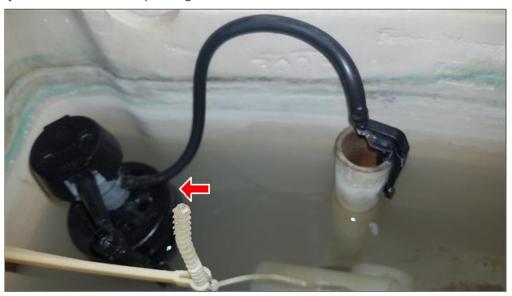
The toilet valve in the 3/4 bath bleeds off and causes the toilet to refill on an approximate 10 minute cycle. Recommend replacing valve.

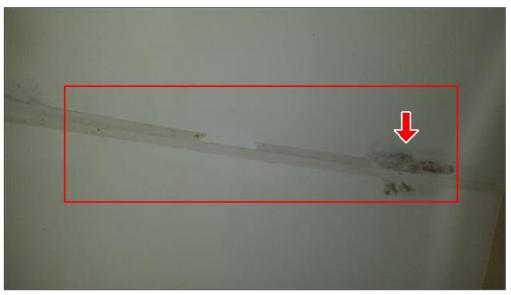
Damaged ceilings throughout the house with possible organic growth indicating a moisture related problem.(ie: lack of ventilation, possible leak) Recommend further evaluation for needed repairs.
